## Returning a North Shore Silverliner to Passenger Service

By Steve Thomas

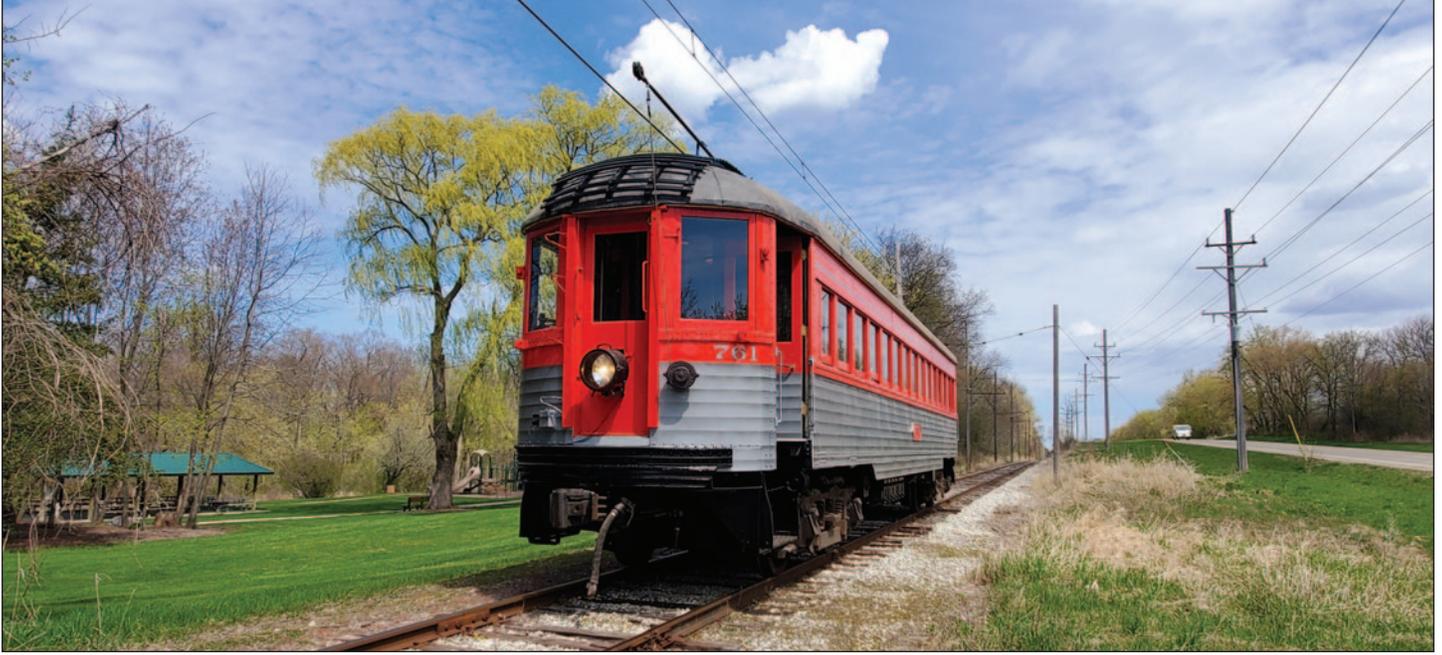
▲ Car 761 on its first test run in April 2021.—Eric Zabelny photo

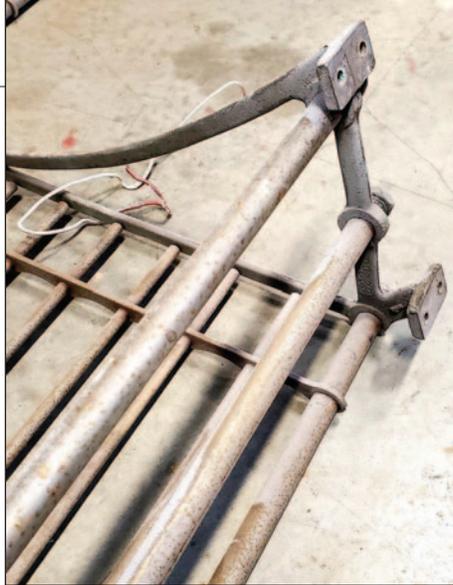
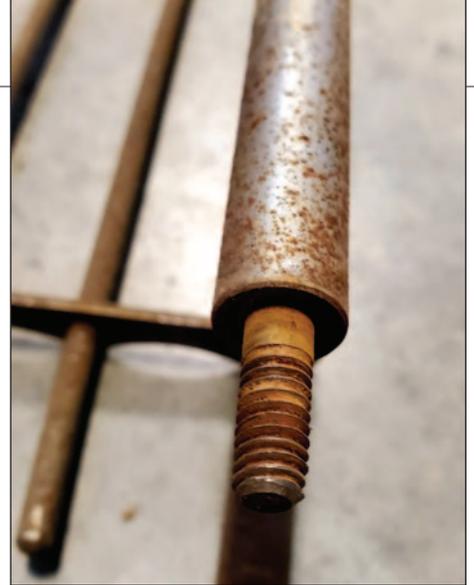
▲ The rusty luggage racks were stored awaiting the budget to have them stripped and recoated with nickel. Paul Averdung later said the process of reinstalling the racks was like assembling a 1,000-piece jigsaw puzzle, since the racks had to be completely disassembled into individual rods and brackets for stripping and recoating.—Eric Zabelny photos

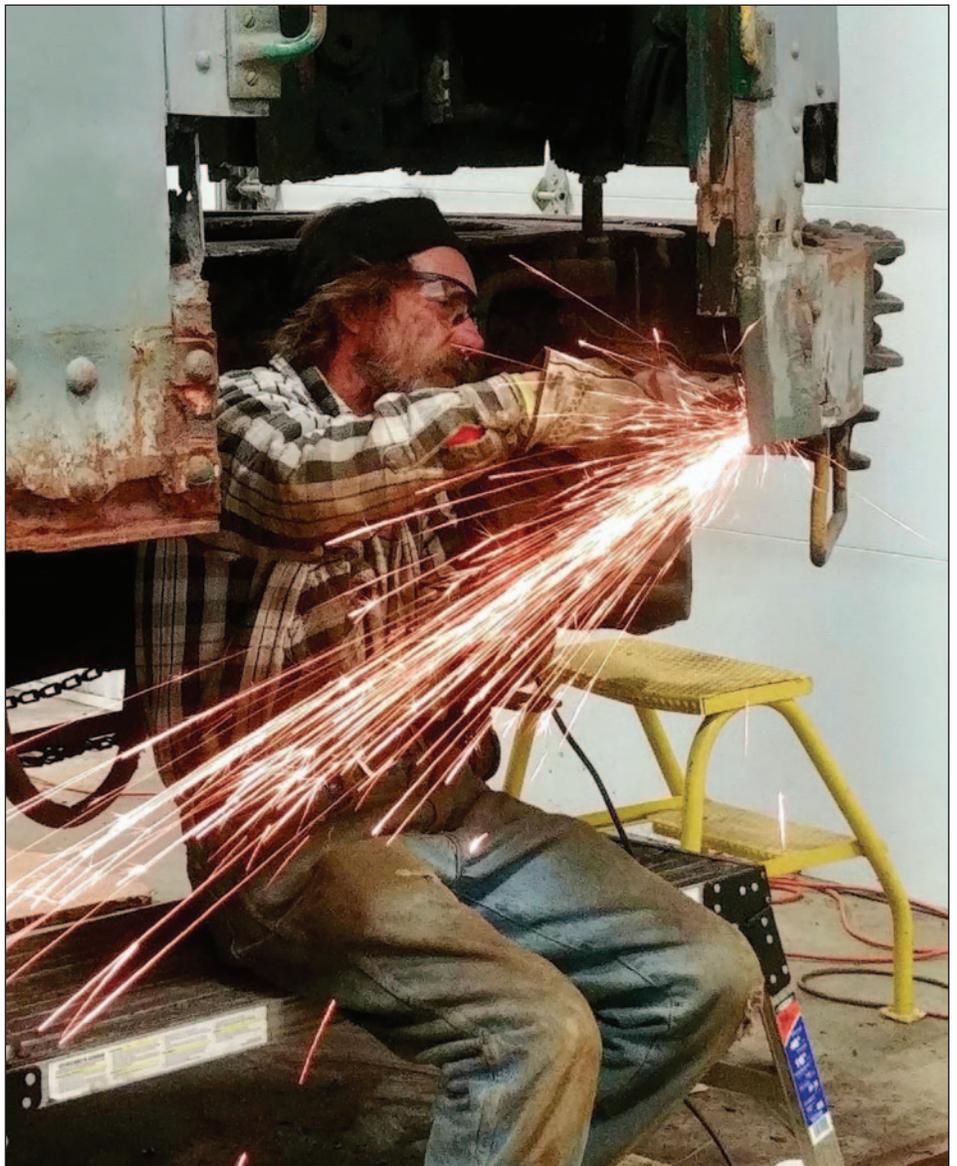
▲ Mike Heck cuts away rotted steel sections in this photo by Eric Zabelny.

Mike Heck began to uncover and remove flooring, rusted steel plate and frame members from the east end of the car. He also cut away rusted steel from the front of the car and slowly began to replace frame members with new steel framing and cut, bent and welded new pieces of steel plate into place on the front of the car.

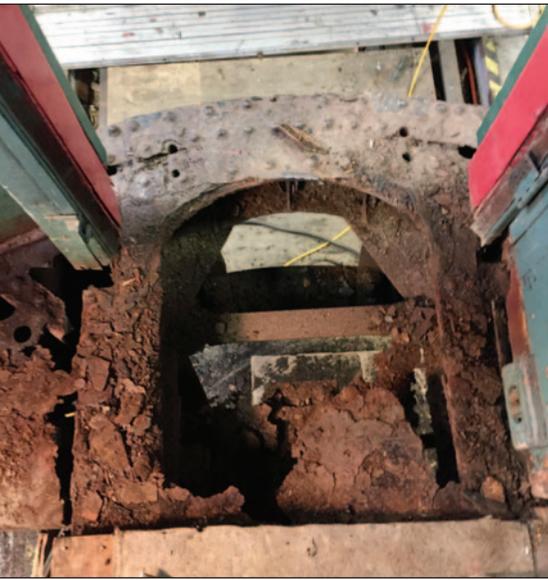
▼ Here's what one of the vestibules looked like after we removed the layers of flooring above the frame.—Eric Zabelny photo

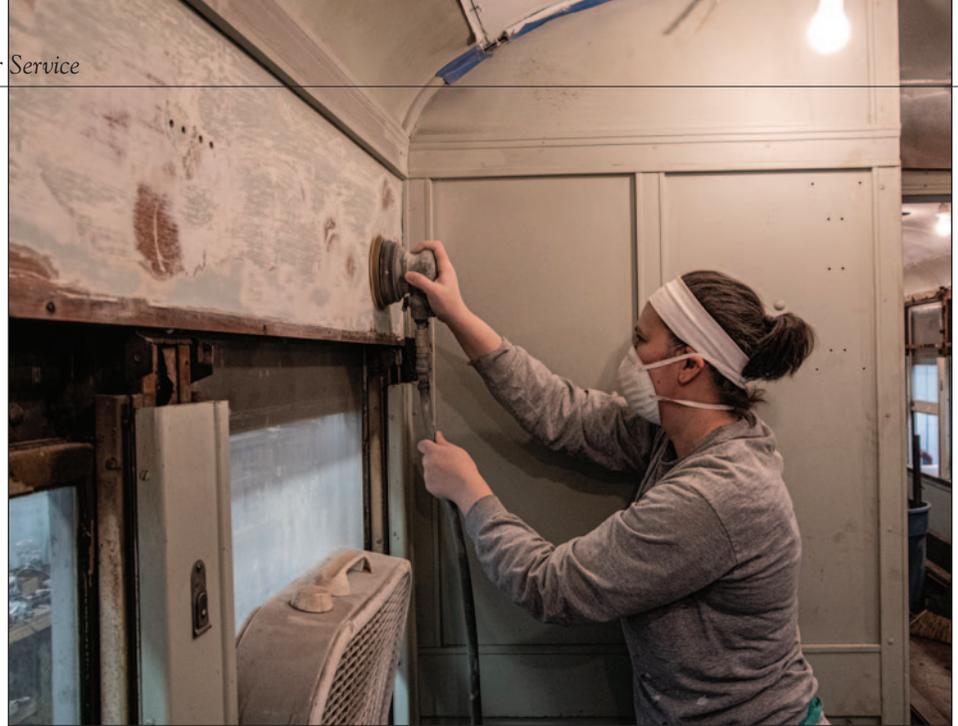
▲ Stephanie Zabelny sands one of the header panels to help prepare the interior for new paint.—Tom Fleming photo

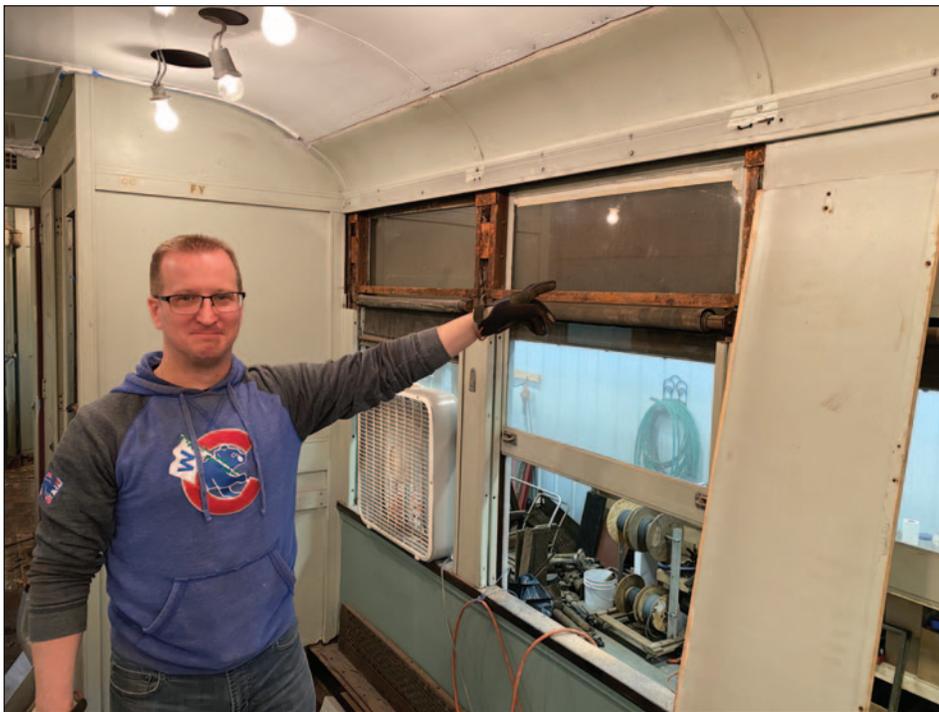
▲ Eric Zabelny points to an open window after it had been cleaned and repaired so that it would open properly. Rotten wood and window frames were repaired or replaced, ensuring that this restoration was more than cosmetic. Eric is another former volunteer who rejoined the railroad to help with Car 761, a restoration project he worked on the first time it started.—Tom Fleming photo

Where necessary, the crew removed and repaired or rebuilt window frames, window guides, window trim and wall panel seg-

ments to make sure the final product would look good and work properly. New window frames were built for both ends of the car, since the originals had been lost or were too deteriorated to reuse.

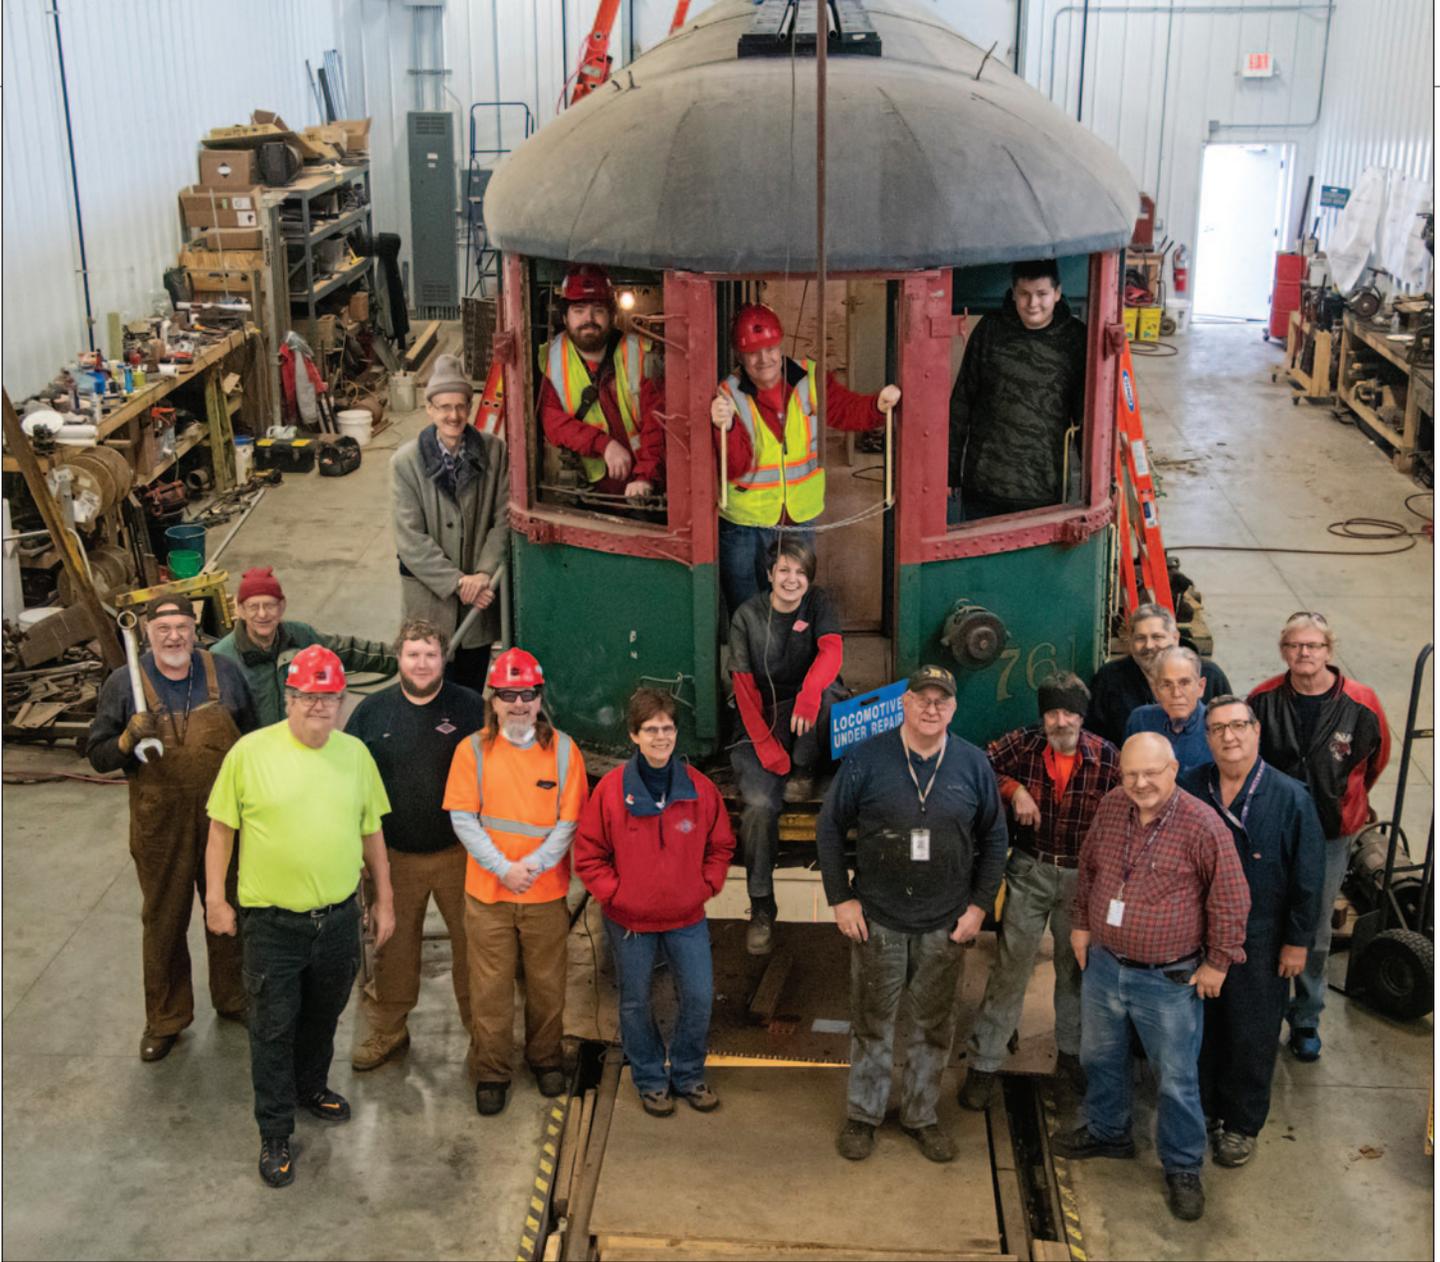
▲ In early March 2020—shortly before the pandemic shut everything down—volunteers helping with the restoration posed with Car 761 in the maintenance facility. You can see new mounting bases for the trolley poles in place atop the car. Standing in the photo from left are Dale Hansen, Paul Averdung, Tom Fleming, Alex Hummel, Steve McCarthy, Sue Budzien, Jerry Borzych, Mike Heck, Patrick Shepherd, Bruce Wilcox, Russell Griswold, Rich Burger and Steve Hitt. Standing or sitting on the car are, from left: Pete Frorath, Chris Schmidt, Evan Richards, Haylee Robinson and Alex Wilcox.—*Dustin Robinson photo*

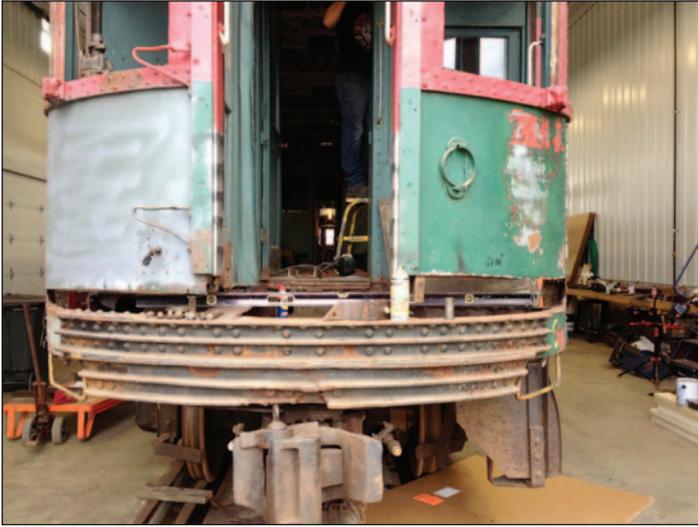
▲ A view of the east end, with the corroded steel cut away in preparation for new replacement steel.

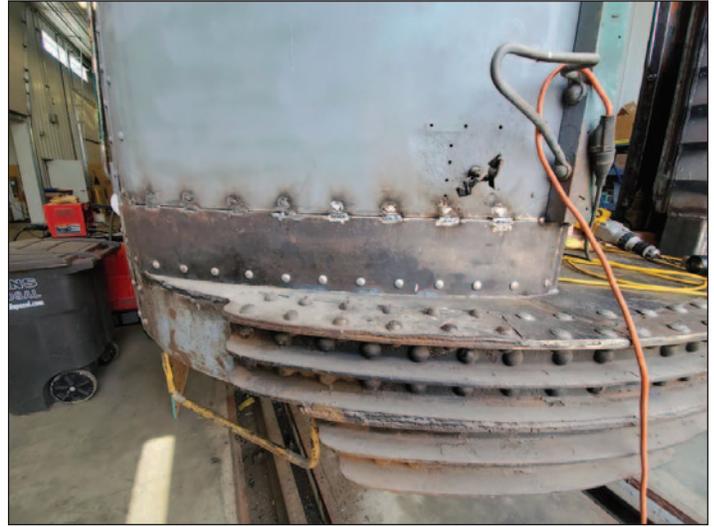
▲ By early May of 2020 the frame had been repaired and new steel was in place on the east end of the car. New steel plate was also installed and welded into place in the vestibule.—Eric Zabelny photo

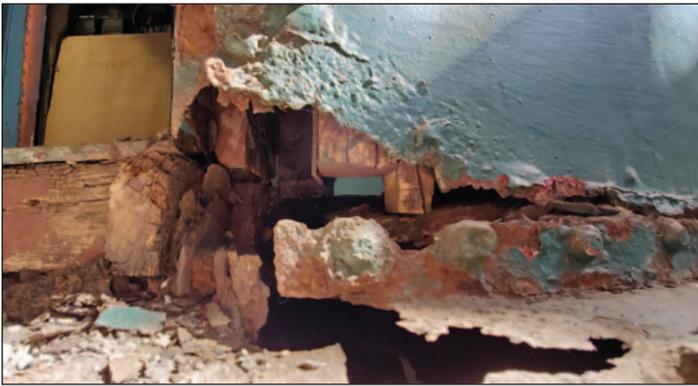
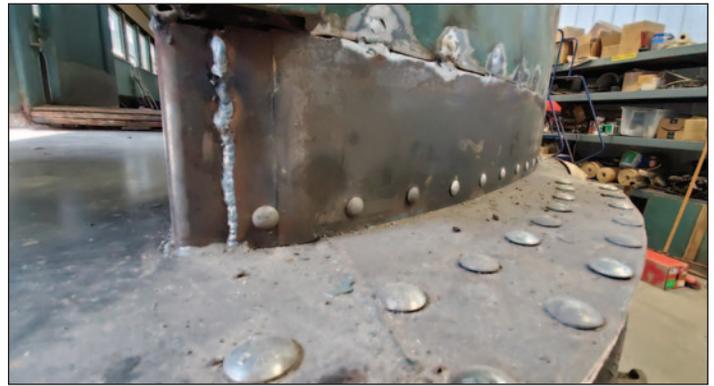
▲ These photos both show one of the west end center posts of the car, with extensive corrosion and rot (left), and with new steel welded in place (right).—Eric Zabelny photos

we found the frame and the plate steel nearly as corroded as the east end. So, after Mike finished the work on the east end,

Jamie Kolanowski joined the team and began the same process of rebuilding on the west end.

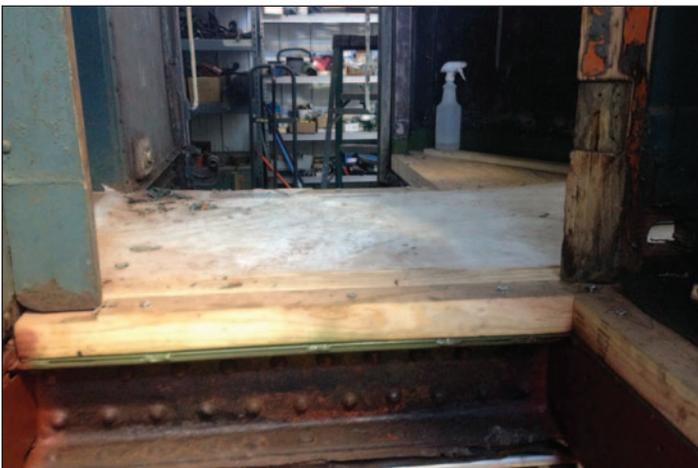
▲ Wood sub-flooring and trim were installed in the east end vestibule by late May of 2020.

Meanwhile, other volunteers began to procure, cut and install sub-flooring and wood trim pieces to bring the east end

floor to its proper level. They found and rehabilitated three of the four stairwells with steel that had been fabricated for them in 2003. Work also picked up on the exterior car body, which included needle scaling, wire wheeling and sanding to prepare the car for exterior paint.

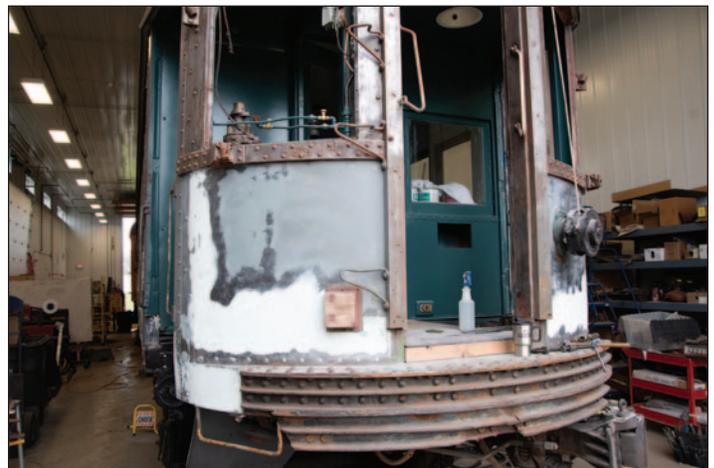
▲ Body filler had been applied over the repaired steel and sanded to prepare the east end for painting.

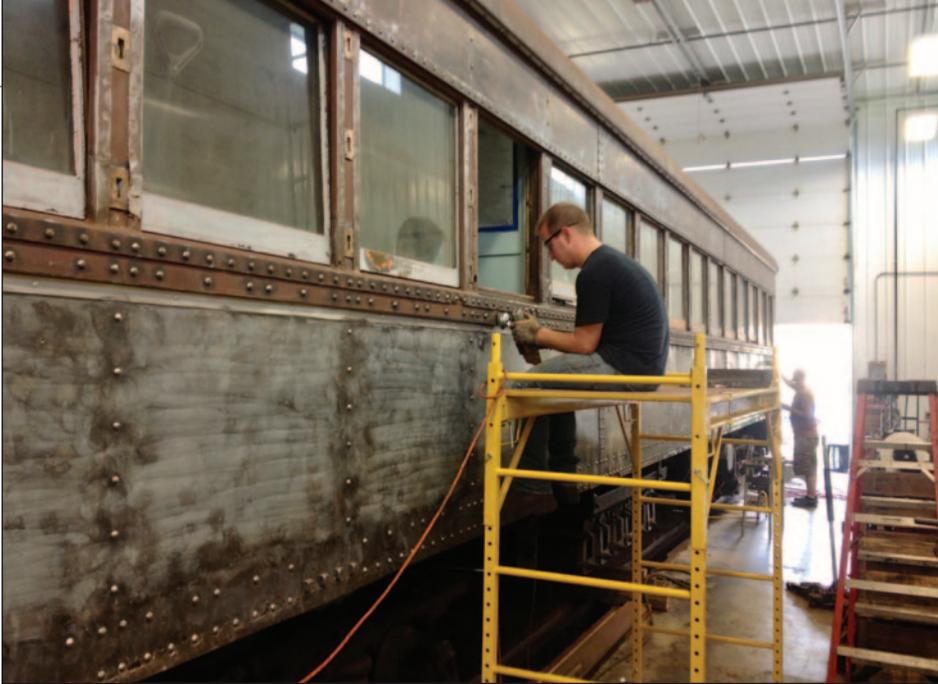
▲ Eric is hard at work grinding rust off of every nook and cranny of the body of the car. This was the most tedious part of the project for him and took three times as long as he estimated it would take.

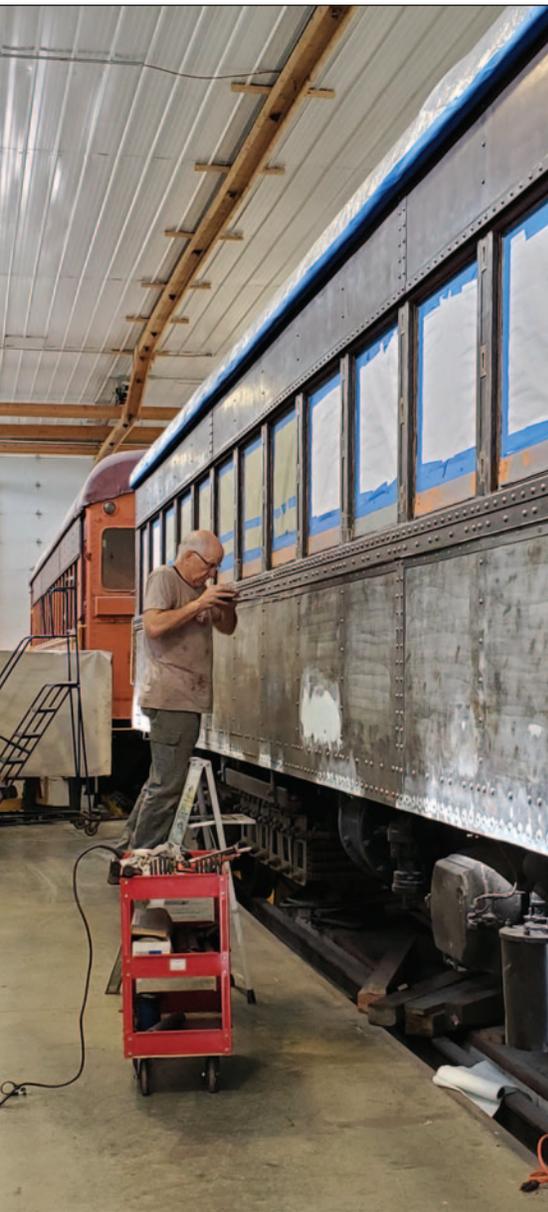
▼ Paul works to secure new steel sections just before the first external painting work. Note that the windows are all taped and ready.—Eric Zabelny photo

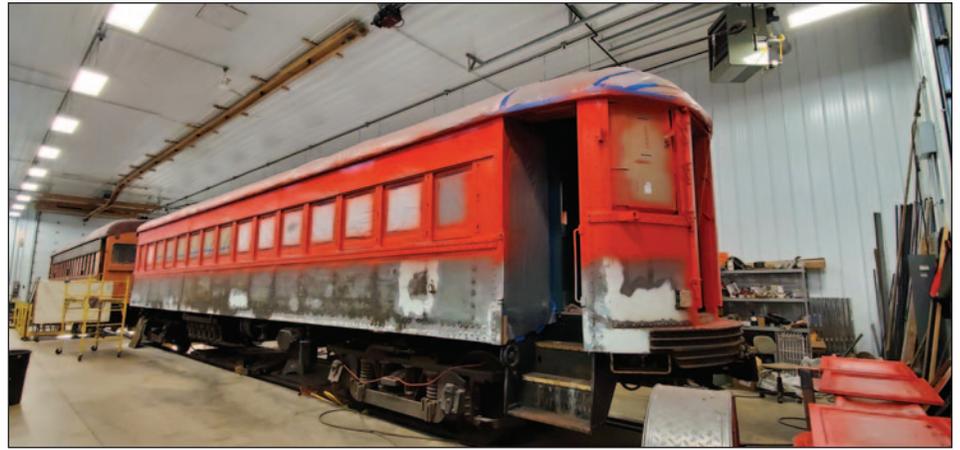
▲ After priming, the coat of red paint had been applied to the top of the car on September 9th.—Eric Zabelny photo

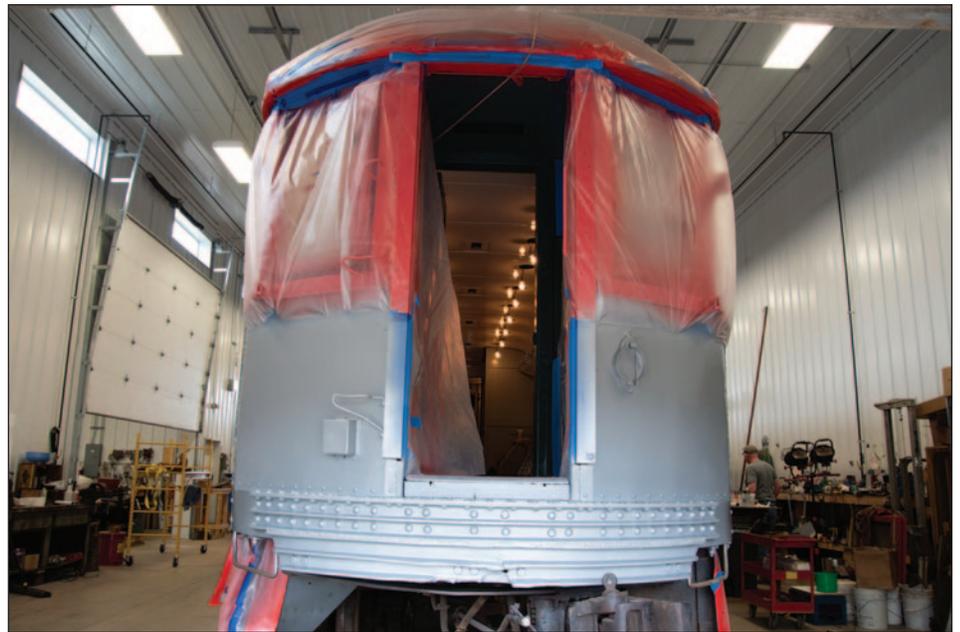
▲ The top of the car was wrapped in plastic and the bottom of the car had been painted with the grey base coat in this September 26th photo.

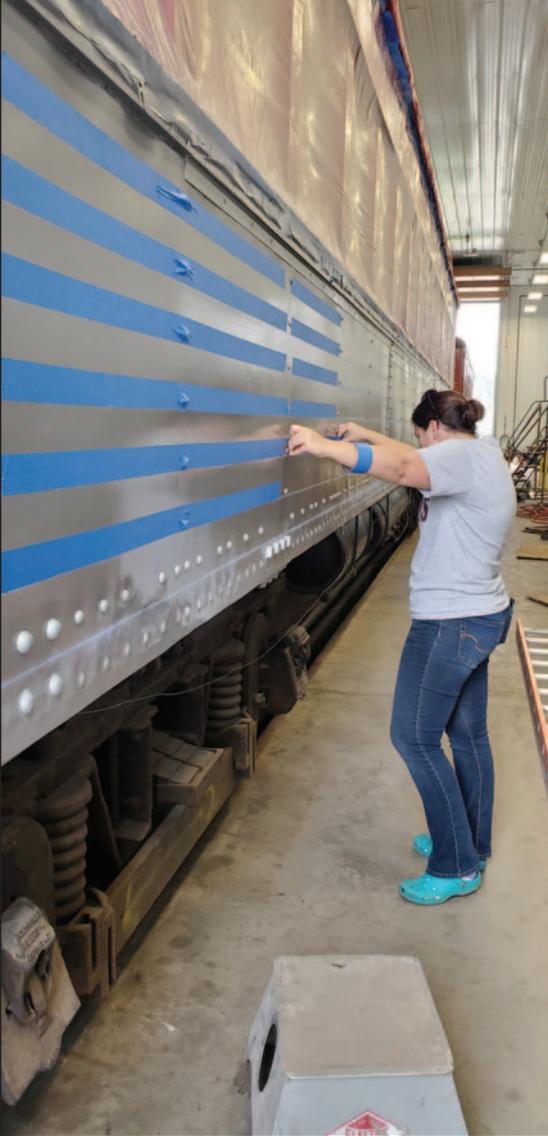
▲ Stephanie Zabelny applies the masking tape necessary to deliver the striping that will give the car a fluted stainless-steel appearance.

Rudolph, had contacted Dennis Storzek, who painted North Shore Silverliner Car 251 at IRM 40 years ago. From memory, Dennis provided pages of detailed instructions on creating the “shadow striping” technique used on the Silverliners. Second, Eric had used the instructions, plus a lot of his own “trial and error” work, to learn the technique.

First, he measured out and started masking the lines. It required a lot of tape and paper to overlap things so the overspray didn’t spoil the areas that weren’t painted yet.

The trickiest part was the shadowing technique itself, which required fine tuning the spray gun, making sure it had the right amount of paint and was set at the right air pressure. After many hours of fine tuning, he felt like he had the technique down pretty well. After painting the first shadow line, Eric’s nerves settled and the

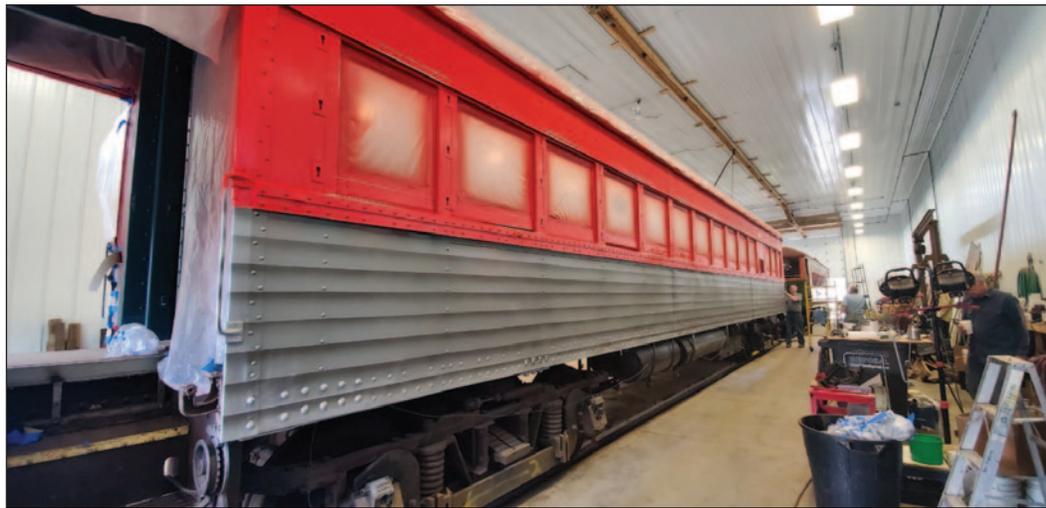
▲ The tape had just been removed, revealing the terrific job done by Eric and Paul to recreate the stainless-steel appearance used by the North Shore line in the 1950s to modernize the look of their cars. You had to touch the car to make yourself believe that it wasn’t fluted stainless-steel.—  
*Eric Zabelny photo*

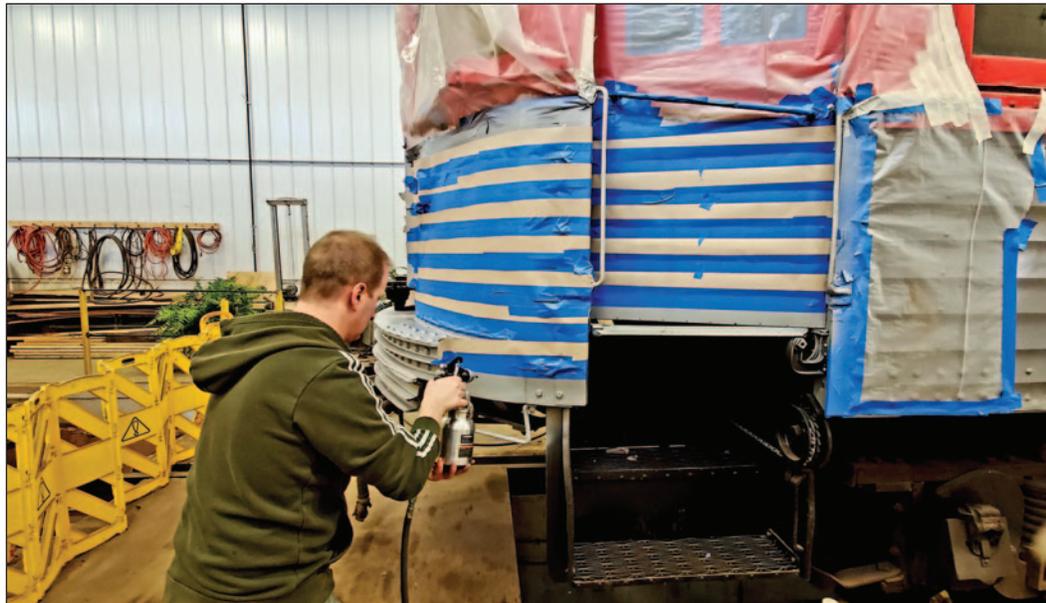
▲ Eric applies the shadow painting to the west end of the car in this photo by Tony Pignaloni.

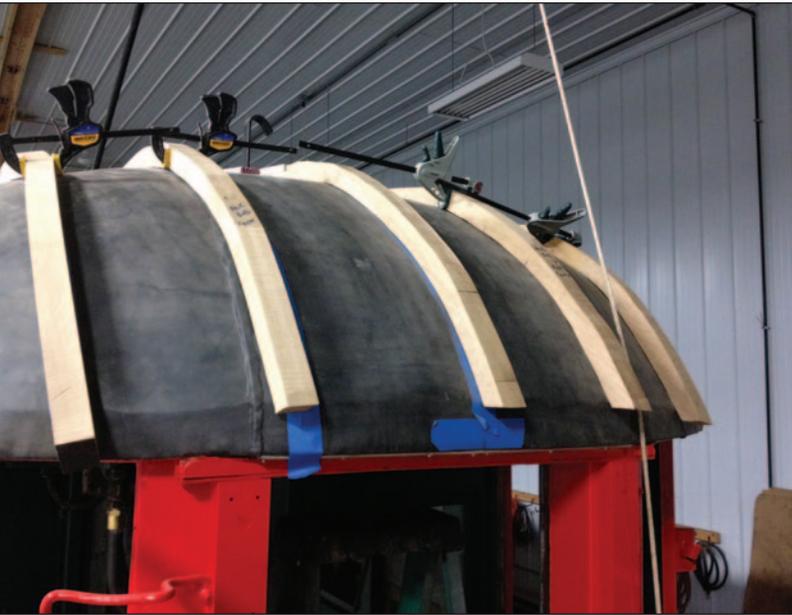
▲ In this photo, taken in late December 2020, Scott Patrick (another returning volunteer) had bent and placed the wood supports for the mats on each end of the car.

With the major painting finished, volunteers worked to finish installing the seats, painted and fit the doors for proper operation, and built the distinctive North Shore roof mats on both ends of the car. All the door handles, locks, vents, lighting fixtures and fans were reinstalled to return the car to its North Shore glory days.

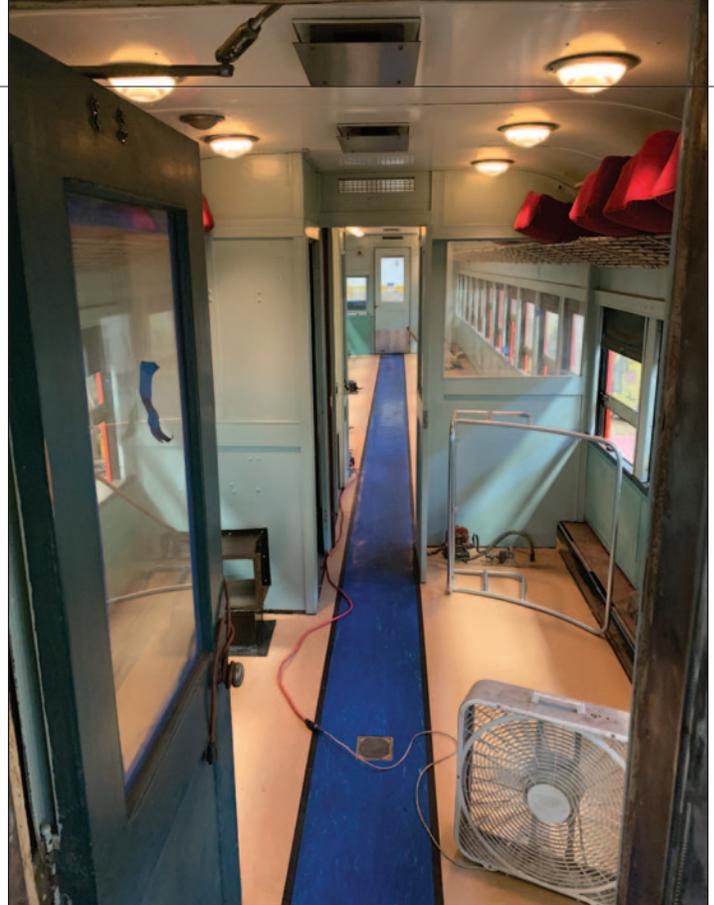
▲ In early January 2021, the interior of the car had been painted, the lighting fixtures and vent hardware had been reinstalled, the luggage racks were in place, and some of the seat mounting bases had been installed. One seat frame and several reupholstered cushions are visible in this photo. We purchased the flooring from the same company that made the flooring for the North Shore Line in the 1950s.

Once the seat frames were back, they were identified for proper placement in the car. There are several sizes of seats and frames, so the arrangement had to be confirmed. The arm rests and upholstered side inserts were reattached to the frames, and then the frames were mounted to the seat bases. The back rests were reattached and the reupholstered cushions returned to each seat once the frames were in place.
